MULTI-FIBER COMPOSITES

R.C. Novak

**United Technologies Research Center
East Hartford, Ct. 06108**

1. Report No. NASA CR-135062		2. Government Accession No.		3. Recipient's Catalog No.	
4. Title and Subtitle MULTI-FIBER COMPOSITES				5. Report Date April 1976

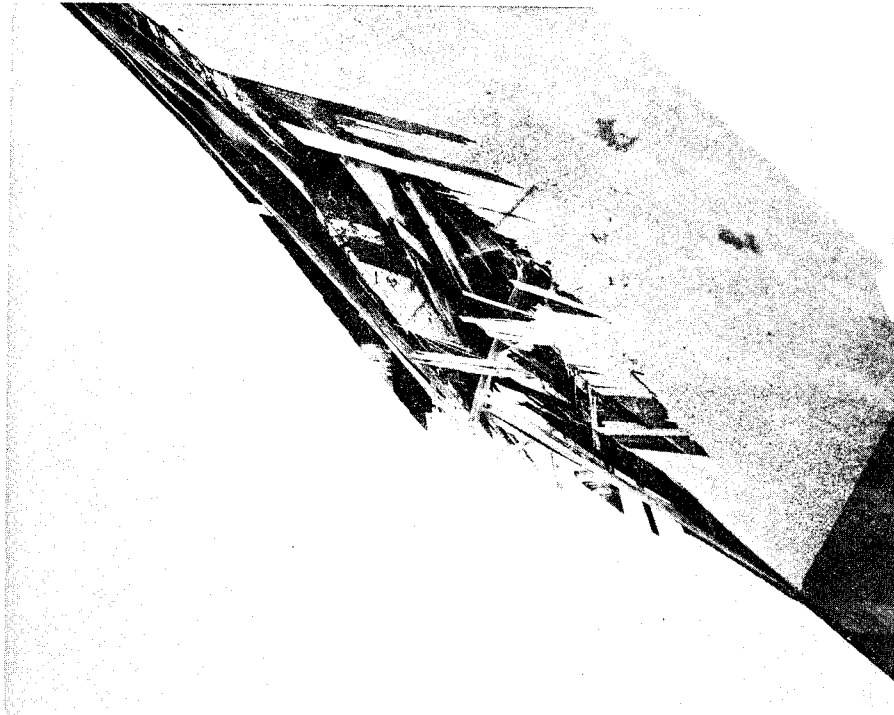
Figures 8 and 9 show the four specimens made from the graphite/glass/epoxy intraply hybrid materials. As is evident in Fig. 8, there was not a substantial difference in the T-300/glass composites with the different glass spacing although the damage was somewhat more extensive with the narrow-spaced material. The AU primary fiber hybrid shown in Fig. 9 suffered the largest amount of delamination losing nearly all of the backface ply, while the AS reinforced

T-300 GRAPHITE/GLASS/EPOXY IMPACTED SPECIMENS

specimen underwent very little delamination but did incur a substantial breakout at the point of impact. Specimens NAS-1 and NAS-6 were subjected to ultrasonic C-scan before and after impact to measure the extent of delamination. The tests confirmed the visual observations in that NAS-1 was delaminated over nearly 100% of its exposed area, while NAS-6 was about 75% delaminated. Based on the tests of the four graphite/glass hybrids it appears that the failure mode in these materials can be varied from primarily delamination to primarily local breakout by increasing the fiber matrix bond strength, but it does not seem possible to avoid a fairly large amount of damage under the given impact conditions.

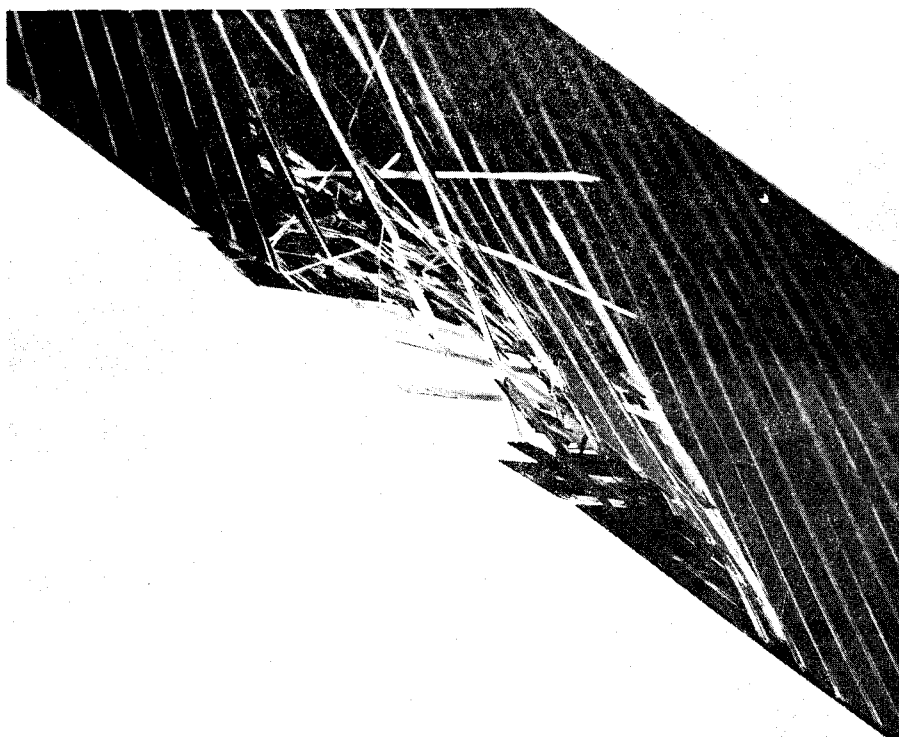
AS GRAPHITE/BORON/GLASS/EPOXY (NAS-54)

The specimens having three or more reinforcing fibers are pictured in Fig. 11. Both materials failed in a local breakout mode, although in neither case was the extent of damage as great as was observed in the AS graphite/glass/epoxy specimen shown in Fig. 9. The boron/glass/polysulfone shell on NAS-56A apparently was quite effective in reducing damage since the specimen was very similar to the AS graphite/glass/epoxy specimen in other respects.

MULTI-FIBER HYBRID IMPACTED SPECIMENS
